Manhole Inspection Summary

Manhole # S49OO_005MH

Insp Date: **12/4/07 11:11 AM**

Location Address: **Ravenwood**

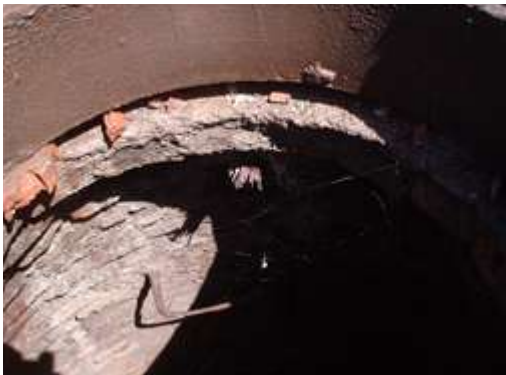
Defect 2

deterioration

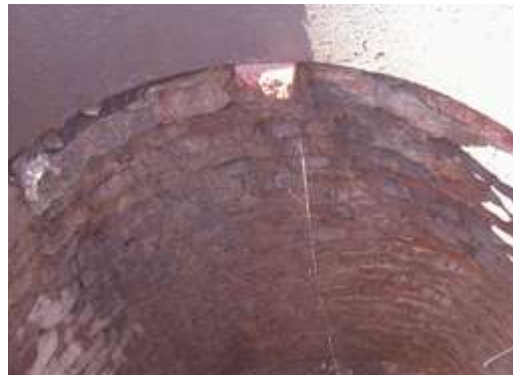
Defect 1

Condition: ☐ Sound ☒ **Cracked** ☐ Root Intrusion ☒ **Loose Brick** ☐ Deteriorated

loose bricks

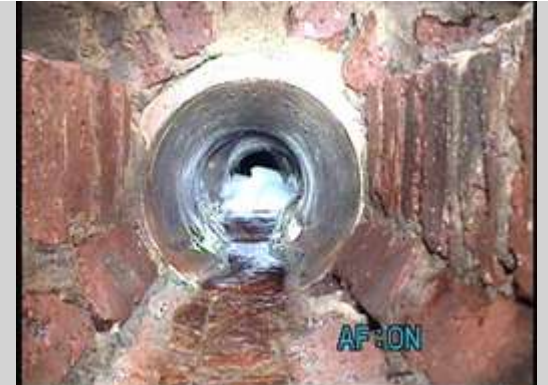
12 O'Clock Outflow

8 in. Circular Gravity Sewer
Pipe Out @ 12 O'Clock

Pipe Height: **8.4** (in.) Rod and Bar (Angled)
Pipe Material: **Clay** ☐ Pipe Lined
Invert Depth: **6.65** (ft.) Flow Characteristics: **Slow**
Deposits: ☐ None ☐ Mud ☐ Sludge ☒ **Debris** ☐ Grease
Silt Depth: **0** (in.) Deposits Extent: **Light**
Infiltration: **None** Pipe Seal Cond: **Sound**

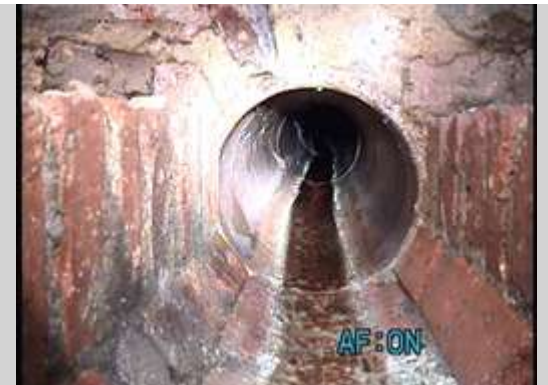
6 O'Clock Inflow

8 in. Circular Gravity Sewer
Pipe In @ 6 O'Clock

Pipe Height: **8.4** (in.) Rod and Bar (Angled)
Pipe Material: **Clay** ☐ Pipe Lined
Invert Depth: **6.60** (ft.) Flow Characteristics: **Slow**
Deposits: ☒ **None** ☐ Mud ☐ Sludge ☐ Debris ☐ Grease
Silt Depth: (in.) Deposits Extent:
Infiltration: **None** Pipe Seal Cond: **Sound**
